DOT/FAA/CT-92/13

Rotorcraft Ditchings and Water-Related Impacts that Occurred from 1982 to 1989 - Phase I

October 1993

Final Report

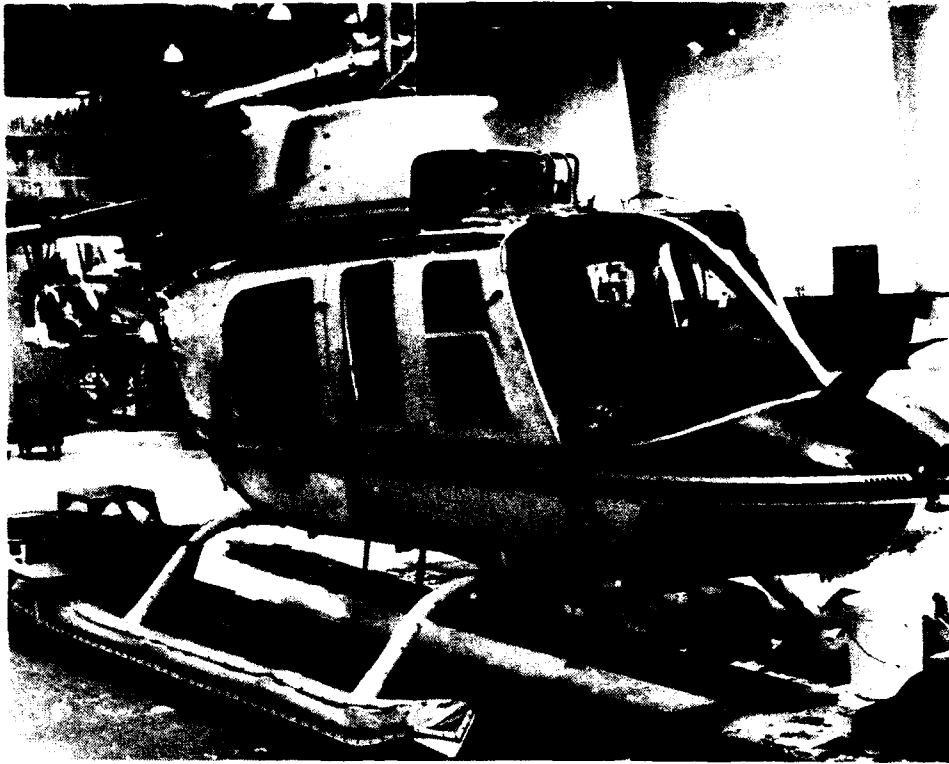
Figure 8.1 Case Study 1, Right Side View of Aircraft

- Tail boom severed in two places, fore and aft of stabilizer.
- Tail rotor blades, hub assembly, gear box, and aft-most section of tail boom missing (figure 8.1).
- Damage to one main rotor blade because of striking tail boom.
- Both chin bubbles broken (figure 8.1).
- Both forward windshields missing (figure 8.1).
- Left passenger door missing (figure 8.2).
- Right passenger door deformed (figure 8.1).
